# THE TECHSMART™ STORY

## Introducing TechSmart™.

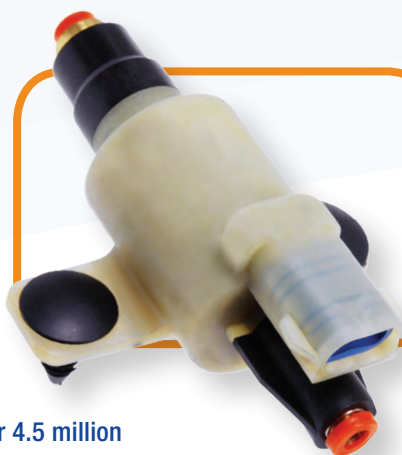
**G35001 Air Suspension Spring Solenoid**  
Ford/Lincoln/Mercury Trucks 2005-95; V10 over 4.5 million

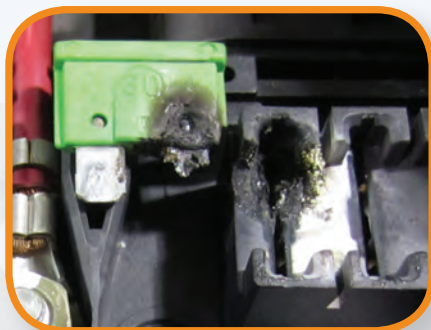
The factory fuse boxes located above the battery on many late model Audi and VW models are prone to extreme heat failure. When these fuses overheat they burn out and often melt the plastic housing around the terminal. Even though the full assembly is typically damaged, replacement parts from the OE are only available as separate components.

OE Unit is Prone to Melting  
and Heat Failure

TechSmart™ has  
the only 'Complete  
Assembly' solution

TechSmart™ provides technicians with a smart solution for this common OE design flaw. The TechSmart™ Power Distribution Center is the only 'Complete Assembly' solution – top cover, lower body, terminals and European color-matched fuses.

After you disconnect the battery and remove the failed OE unit, install TechSmart™ R45001 Power Distribution Center. Reconnect the battery and check the amperage draw of the original failed circuit. If the amperage draw in the circuit exceeds OE specifications, replace the failed component in order to prevent a repeat failure.

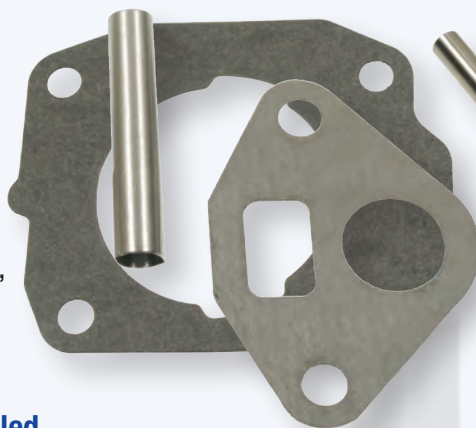
B22001  
EGR Tool Kit  
Honda 2001-98,  
Acura 99  
VIO .5 million

TechSmart™ introduces a smart solution to the EGR clogging problem on Honda Accord and Acura TL V6 models.

Due to a poor OE intake manifold design, the EGR port on these vehicles becomes backed up with carbon buildup often causing a check engine light and emissions failure.

The TechSmart™ reusable EGR Tool Kit is paired up with our EGR Repair Kit to unclog the EGR port and return the valve assembly to proper working order!

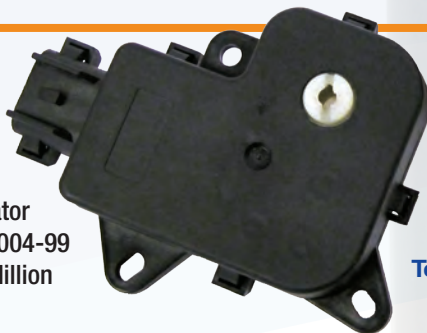
J04002 HVAC  
Air Door Actuator  
Jeep Trucks 2004-99  
VIO over 1.2 Million

**TechSmart™ HVAC  
Air Door Actuator  
Matches the Original**

TechSmart™ introduces the finest quality **OE-matching** HVAC Temperature Blend and Recirculation Door Actuator for late-model Jeep Grand Cherokees. TechSmart™ parts are engineered for a perfect fit every time.

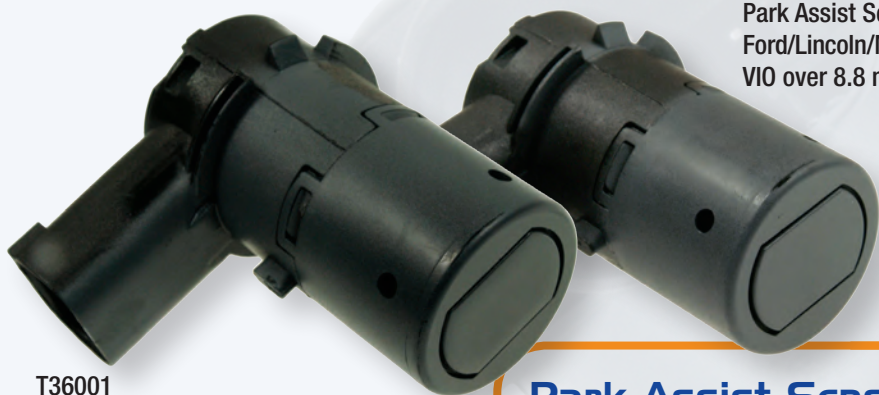
**T36001**  
Park Assist Sensor  
Ford/Lincoln/Mercury 2011-05  
VIO over 1.2 million

TechSmart™ offers its introductory line of Ford OE-specific premium Park Assist Sensors. Also known as back-up sensors, this advanced safety technology will soon be mandatory on all new vehicles. Count on TechSmart™ to provide proven quality for these key safety elements.
